SUBJECT: Section 401 - Water Quality Certification
Madison County, Item No. 7-192.20
Berea Bypass, Section 2

APPLICATION FOR PERMIT TO CONSTRUCT ACROSS OR ALONG A STREAM
AND / OR WATER QUALITY CERTIFICATION

Kentucky Transportation	BEREA BYPASS			STREAM:	
	COUNTY: MADISON	STATE: KENTUCKY	STA 107+00 - STA 119+00	ITEM: 7-192.20	VICINITY MAP

SUMMARY OF SECTION 404 IMPACTS

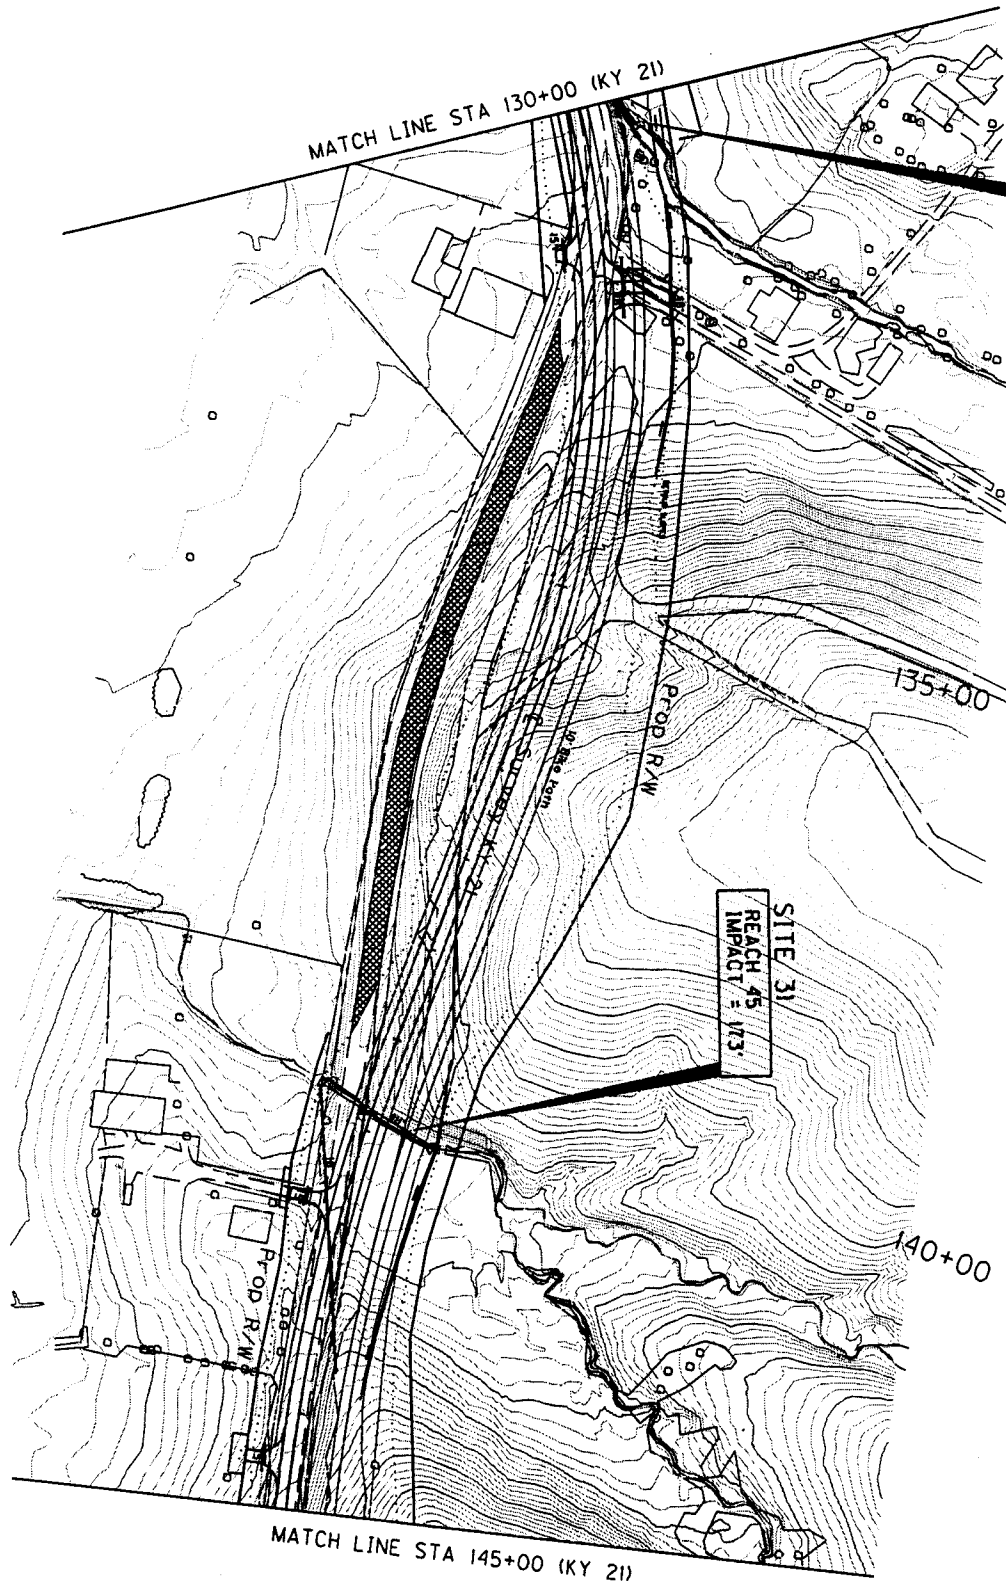
SITE 31
REACH 45
IMPACT = 173'

31. Sta. 140+80 – Construct 123' of pipe culvert, with 30' of outlet channel improvement; on an **intermittent** tributary (Reach 45) of East Fork Silver Creek. This replaces **173'** of existing channel (including 39' of existing culvert). The impact to waters is **0.006 acres**. The drainage area affected is **50.2 acres**. The site is located at N37-33-37, W84-15-01. (Nationwide Permit No. 14)

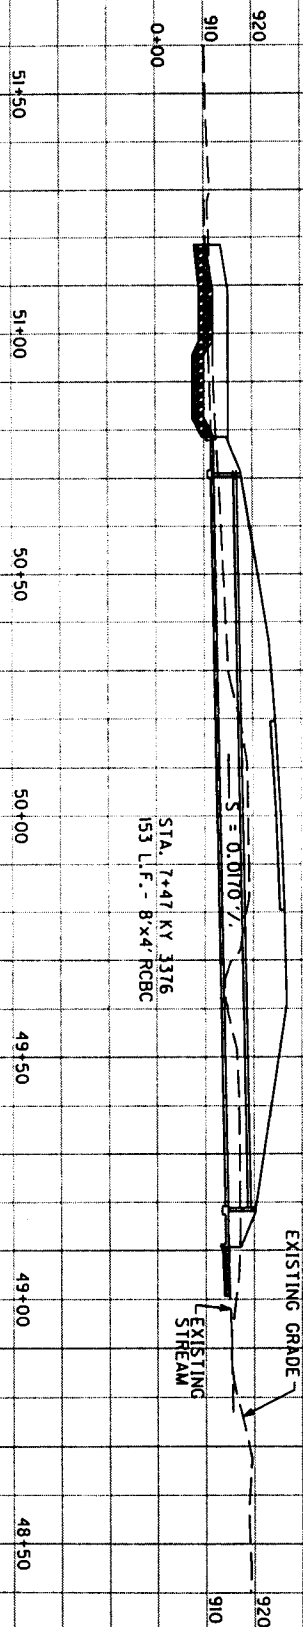
STA. 7+47 KY 3376
153 L.F. - 8"x4" RCBC

5. Right Sta. 155+16.47 (KY 3376, Sta. 7+47) – Construct 153' of 8'X 4' box culvert, with 10' of inlet and 40' of outlet channel improvements; on a **perennial** tributary (Reach 12 DS) to Terrill Branch. This replaces **243'** of existing channel (including 25' of existing box culvert). The impact to waters is **0.022 acres**. The drainage area affected is **127.2 acres**. The site is located at N37-35-39, W84-15-57. (Nationwide Permit No. 14, WQC)

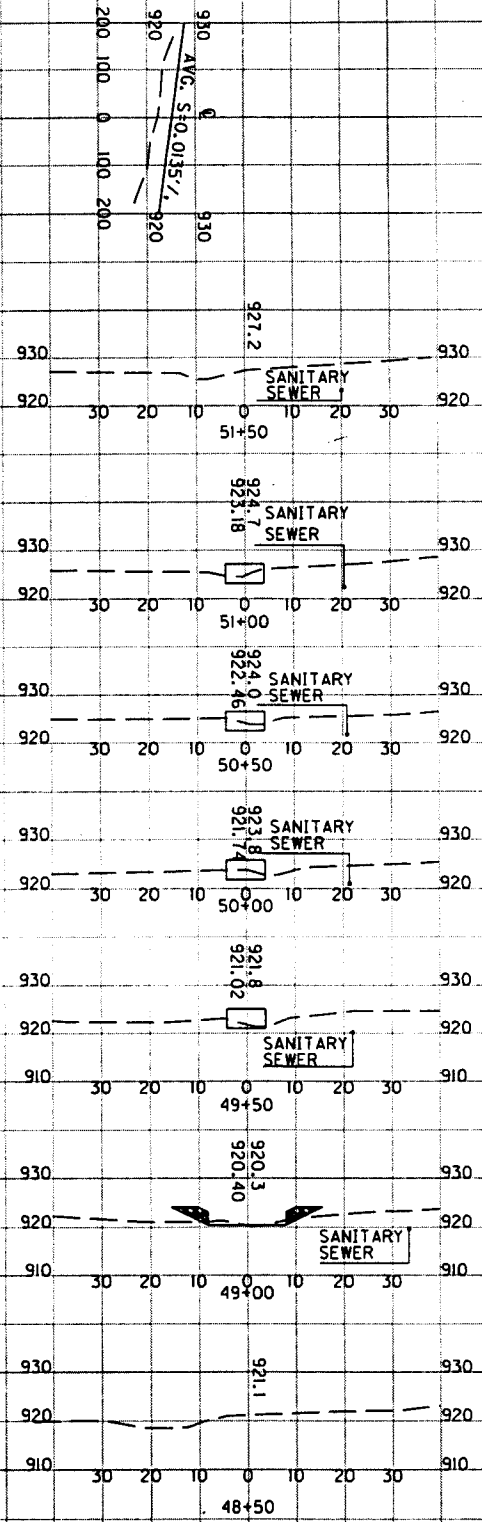
STA. 157+43 MAINLINE
209 LF- 8"x4' RCBC

6. Sta. 157+43 – Construct 209' of 8'X 4' box culvert, with 10' of inlet and 40' of outlet channel improvements; on a **perennial** tributary (Reach 12US) to Terrill Branch. This replaces **271'** of existing channel. The impact to waters is **0.019 acres**. The

drainage area affected is **109.8 acres**. The site is located at N37-35-40, W84-15-54. (Nationwide Permit No. 14, WQC)
